# Isothermal Fatigue, Damage Accumulation, and Life Prediction of a Woven PMC

Andrew L. Gyekenyesi  
Cleveland State University, Cleveland, Ohio

Prepared under Grant NAS3-1543

This dissertation focuses on the characterization of the fully reversed fatigue behavior exhibited by a carbon fiber/polyimide resin, woven laminate at room and elevated temperatures. Nondestructive video edge view microscopy and destructive sectioning techniques were used to study the microscopic damage mechanisms that evolved. The elastic stiffness was monitored and recorded throughout the fatigue life of the coupon and later utilized as a damage variable for a phenomenological model. In addition, residual compressive strength tests were conducted on fatigue coupons with various degrees of damage as quantified by stiffness reduction. Experimental results indicated that the monotonic tensile properties were only minimally influenced by temperature, while the monotonic compressive and fully reversed fatigue properties displayed noticeable reductions due to the elevated temperature. The stiffness degradation, as a function of cycles, consisted of three stages; a short-lived high degradation period, a consta

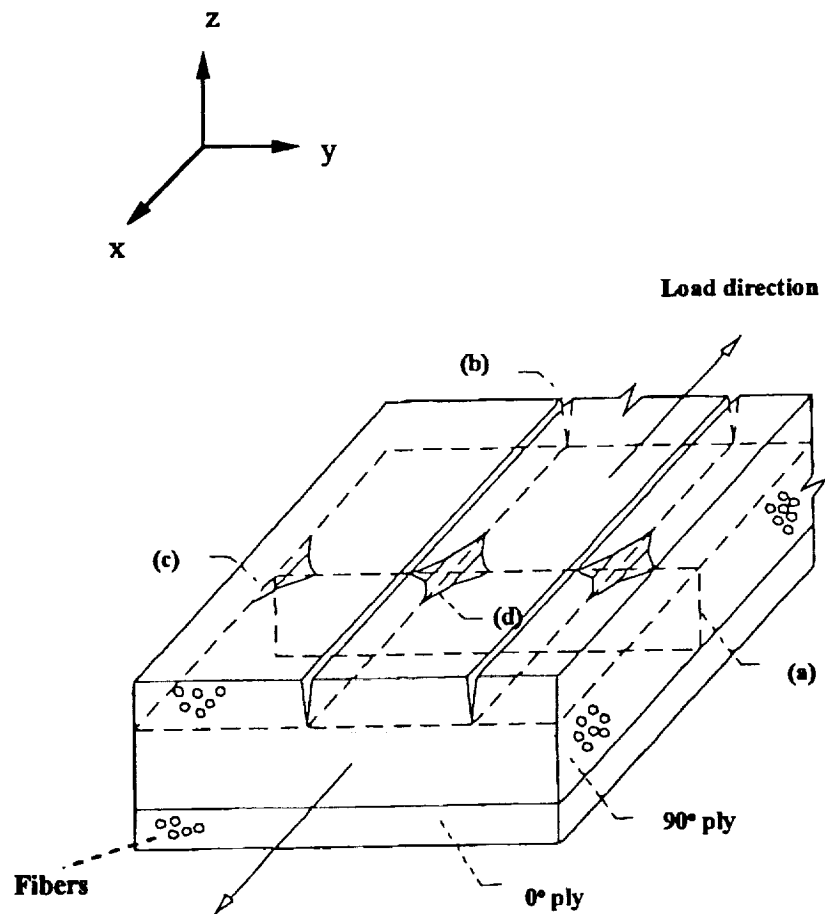
**Figure 1.2** Matrix dominated cracking events. (a) Transverse crack, (b) Longitudinal splitting, (c) Free-edge 0/90 delamination, (d) 0/90 delamination induced by crossing cracks.

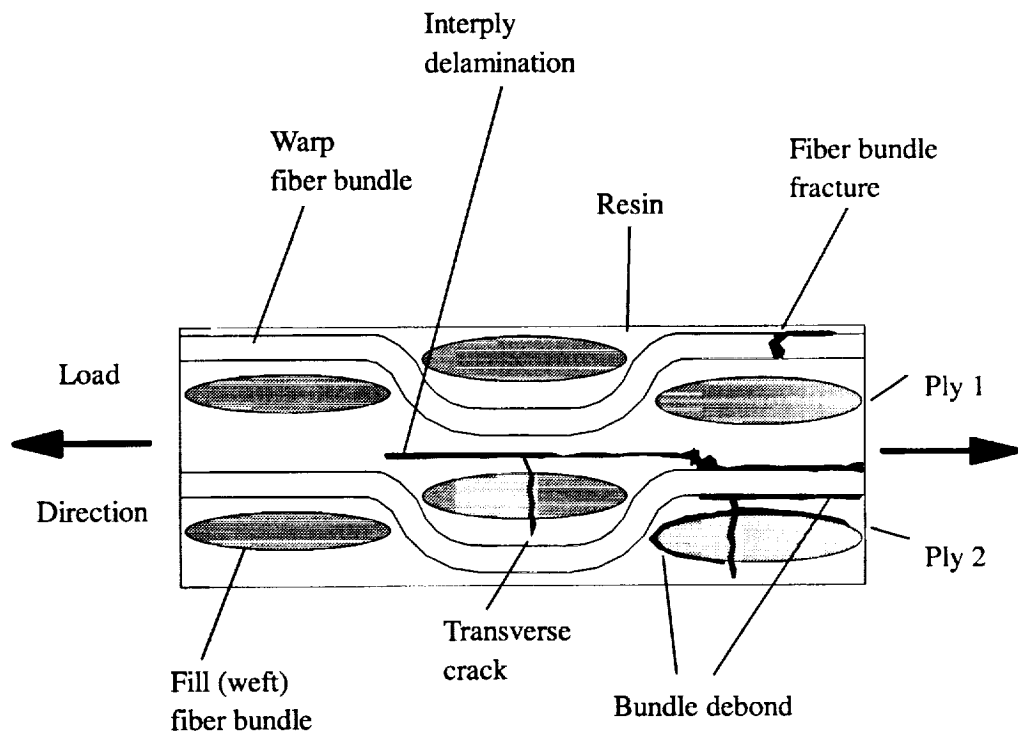
**Figure 1.3** Illustration of fatigue damage in a (0/90) weave: Edge -view.

A generalized schematic identifying various microscopic damage mechanisms for this composite material is depicted in Figure 1.3. During room temperature tests, transverse cracks were initiated at approximately 379 MPa (55 ksi), and these cracks continued to accumulate up to failure. Evidence of this behavior was obtained from the edge view camera and by interrupting monotonic tests at predetermined stress levels. The specimens from the interrupted tests were subsequently sectioned and viewed under magnification. Figure 3.3 illustrates the accumulated damage characterized by a destructive examination of an interrupted test at 758 MPa (110 ksi). The cracks appearing in this figure were viewed from the specimen edge and face (view #2 and view #4 - see Figure 2.7). The transverse crack counts (normalized with respect to observation length and number of plies) were obtained at the interrupted stress levels of 379 MPa (55 ksi) and 758 MPa (110 ksi). Crack counts were only obtained from test specimens that were sectioned. At 379 MPa (55 ksi) the crack count was 0.5 cracks/cm·ply (1.3 cracks/in·ply) while at 758 MPa (110 ksi) it was

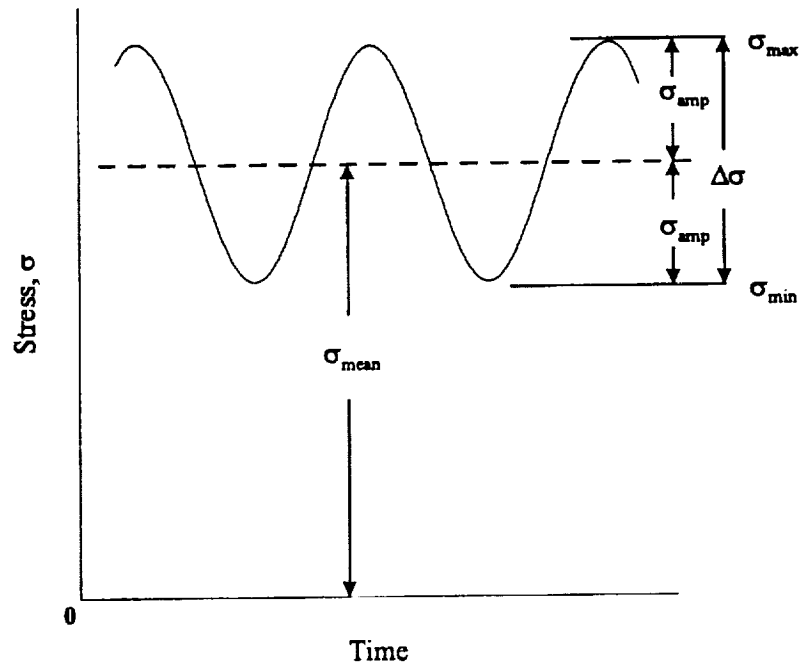
**Figure 1.4** Schematic representation of stress/time relationship for load controlled fatigue.

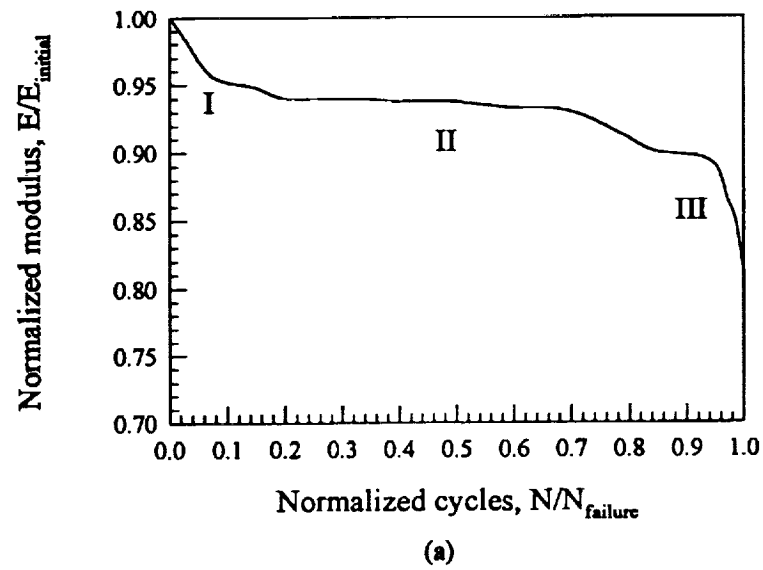
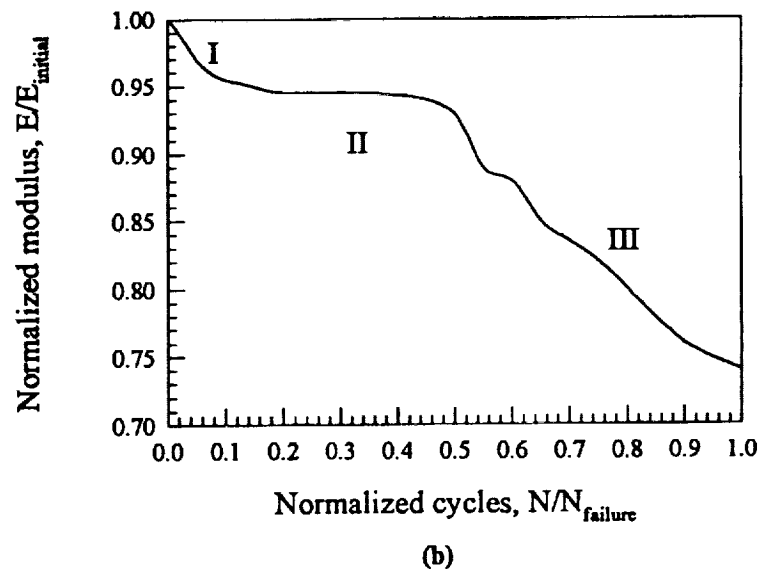
**Figure 1.5** (a) Typical three stage stiffness reduction for  $(0_2/90_2/0_2/90_2)_s$  carbon/epoxy laminate. (b) Stiffness degradation for a carbon/epoxy 8-harness satin cross-weave (Schulte (1986)).

A three stage stiffness degradation plot of a cross-weave laminate is depicted in Figure 1.5 (b). The experimental conditions for the figure are the same as for the cross-ply appearing in the same figure. As is the case for non-wovens, transverse cracks dominate the

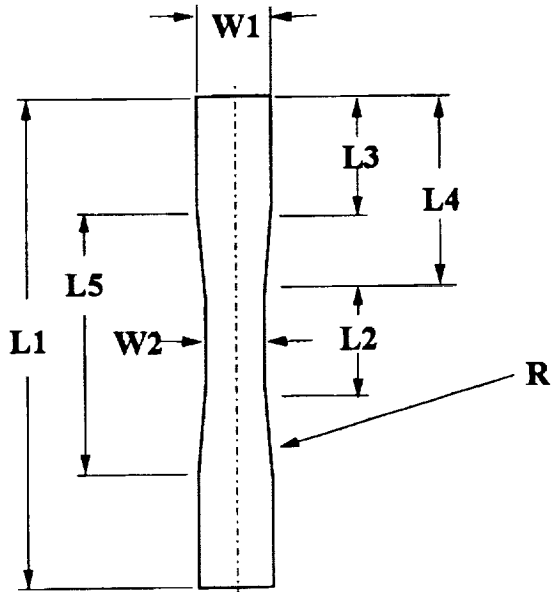
**Figure 2.1** General schematic of specimen geometry.

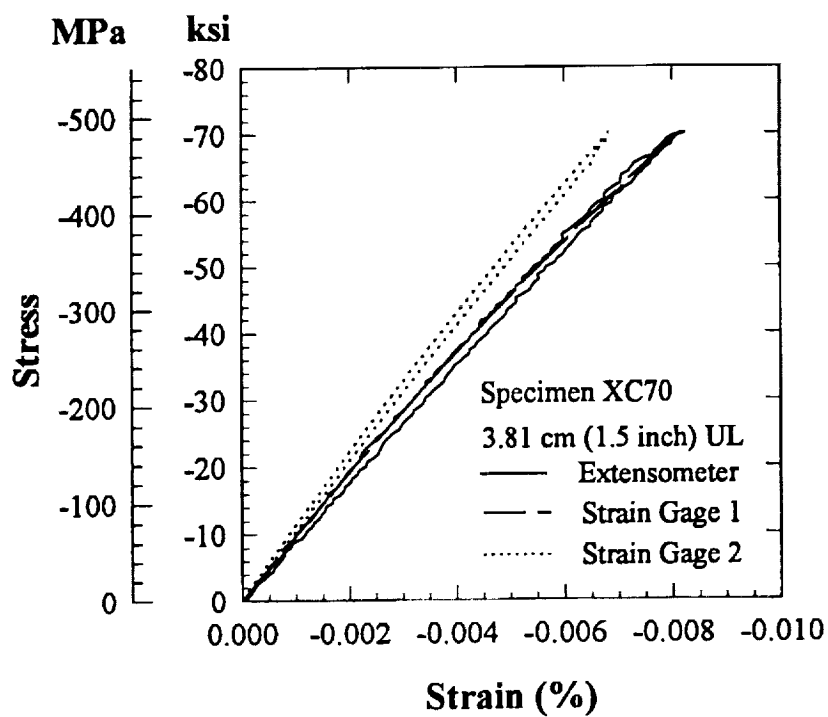
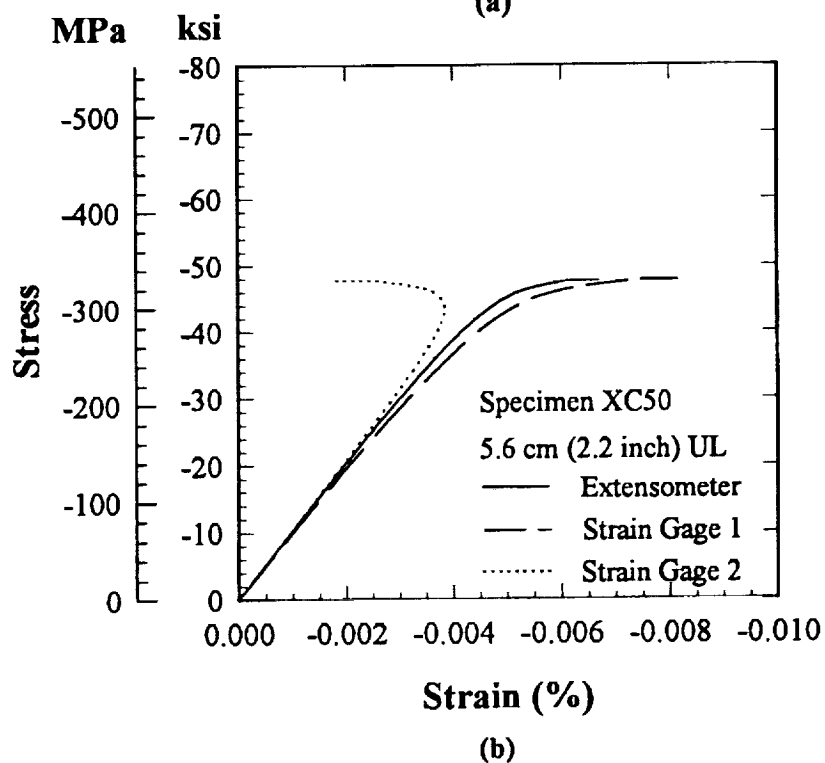
**Figure 2.2** Preliminary compressive tests to study buckling as a function of unsupported length (UL). (a) No apparent buckling. (b) Strain gage behavior indicative of buckling.

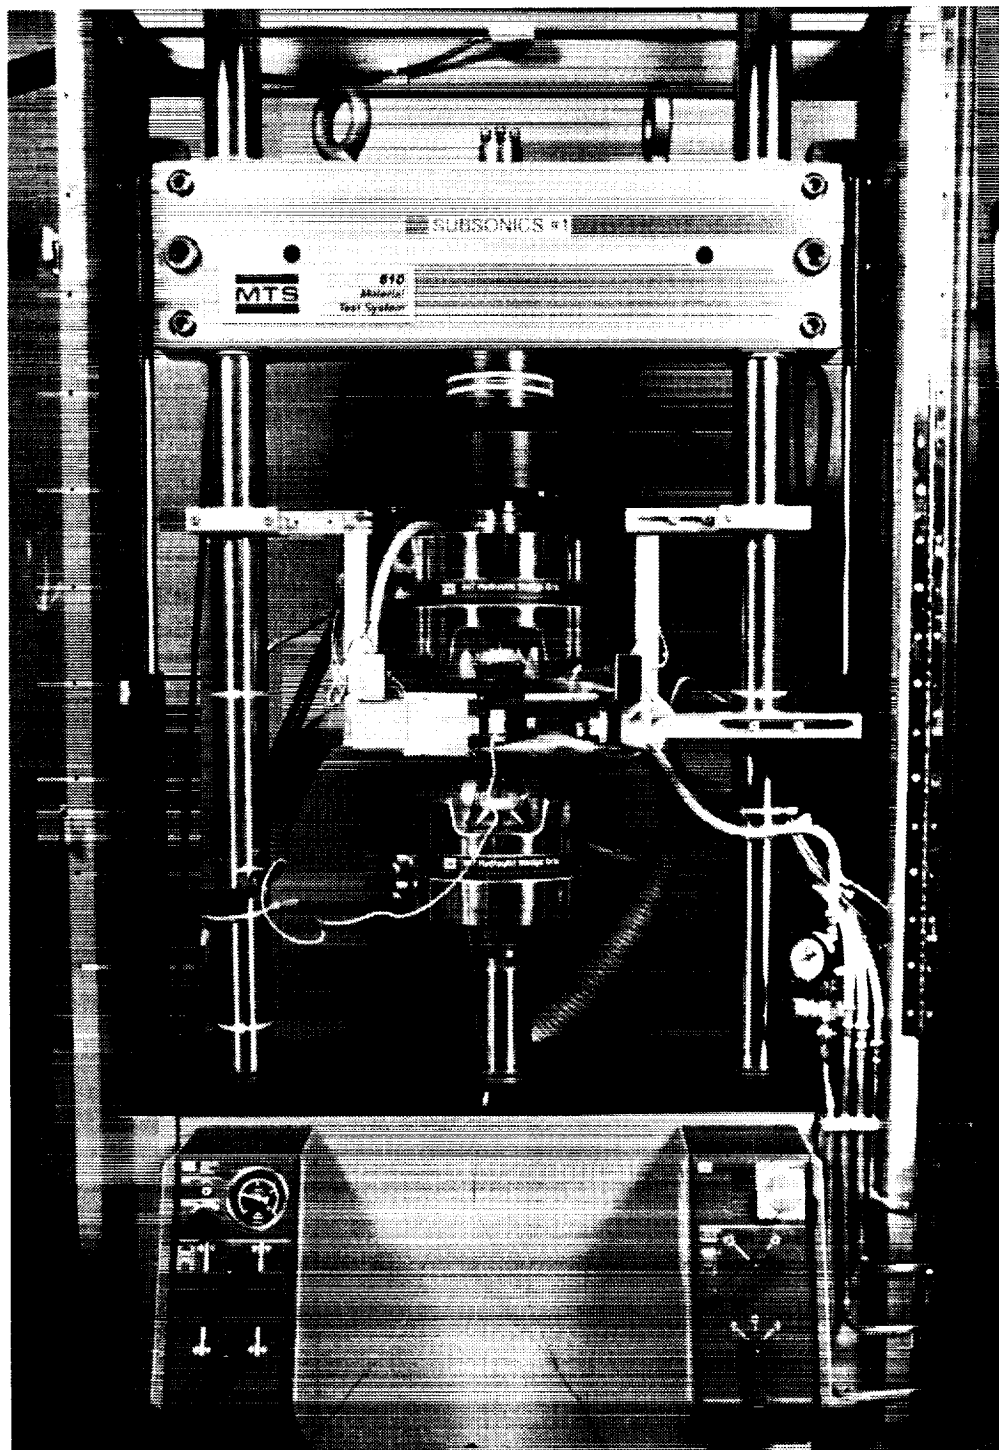
**Figure 2.3** Uniaxial composite test system.

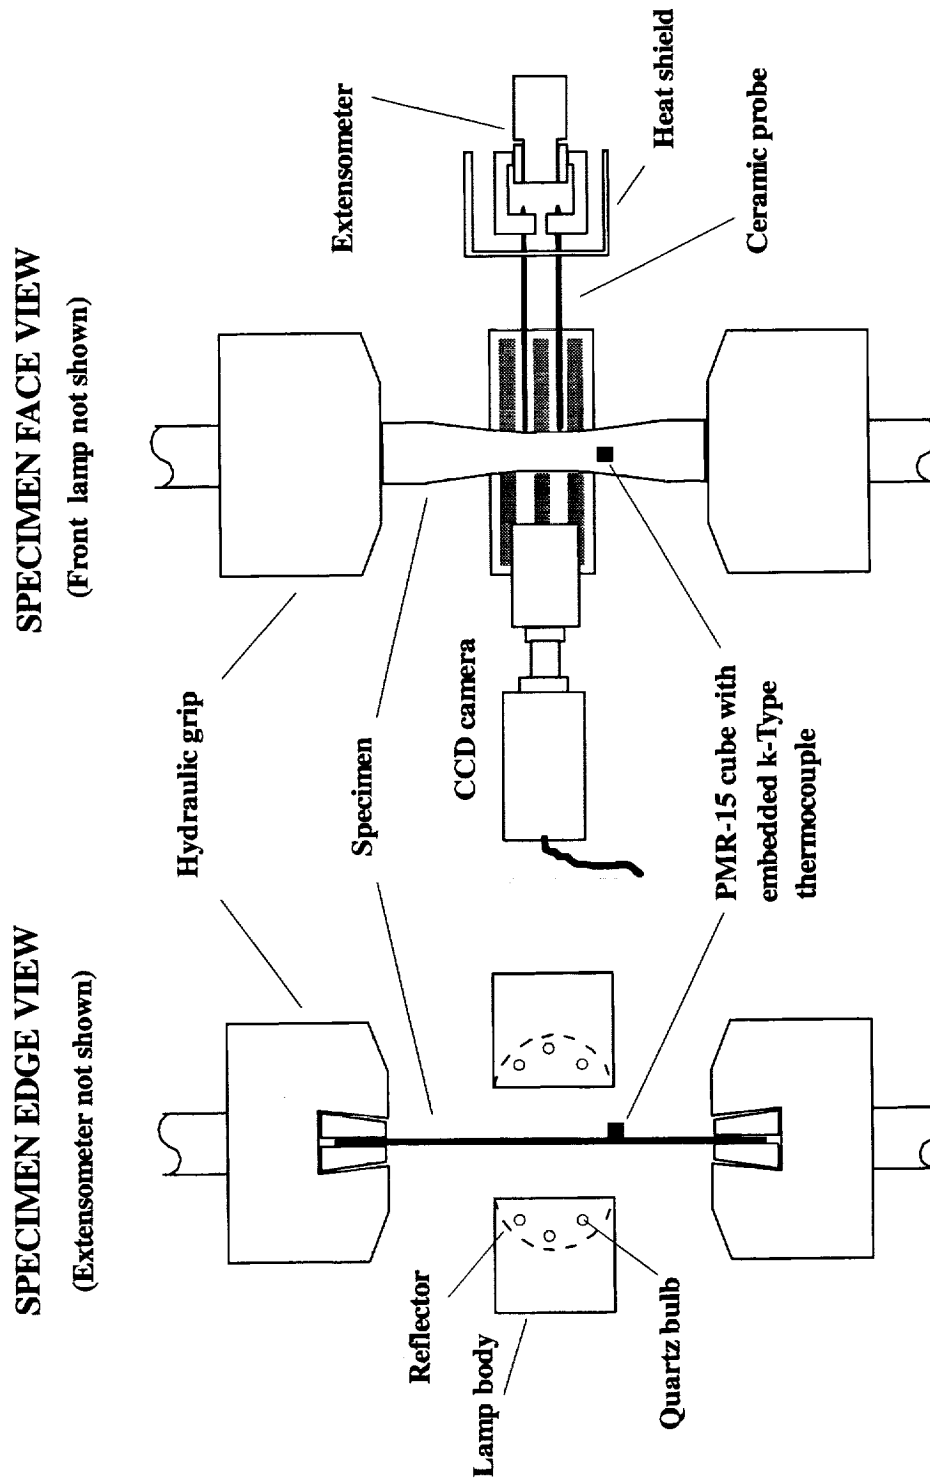
Figure 2.4 Schematic of test set-up.

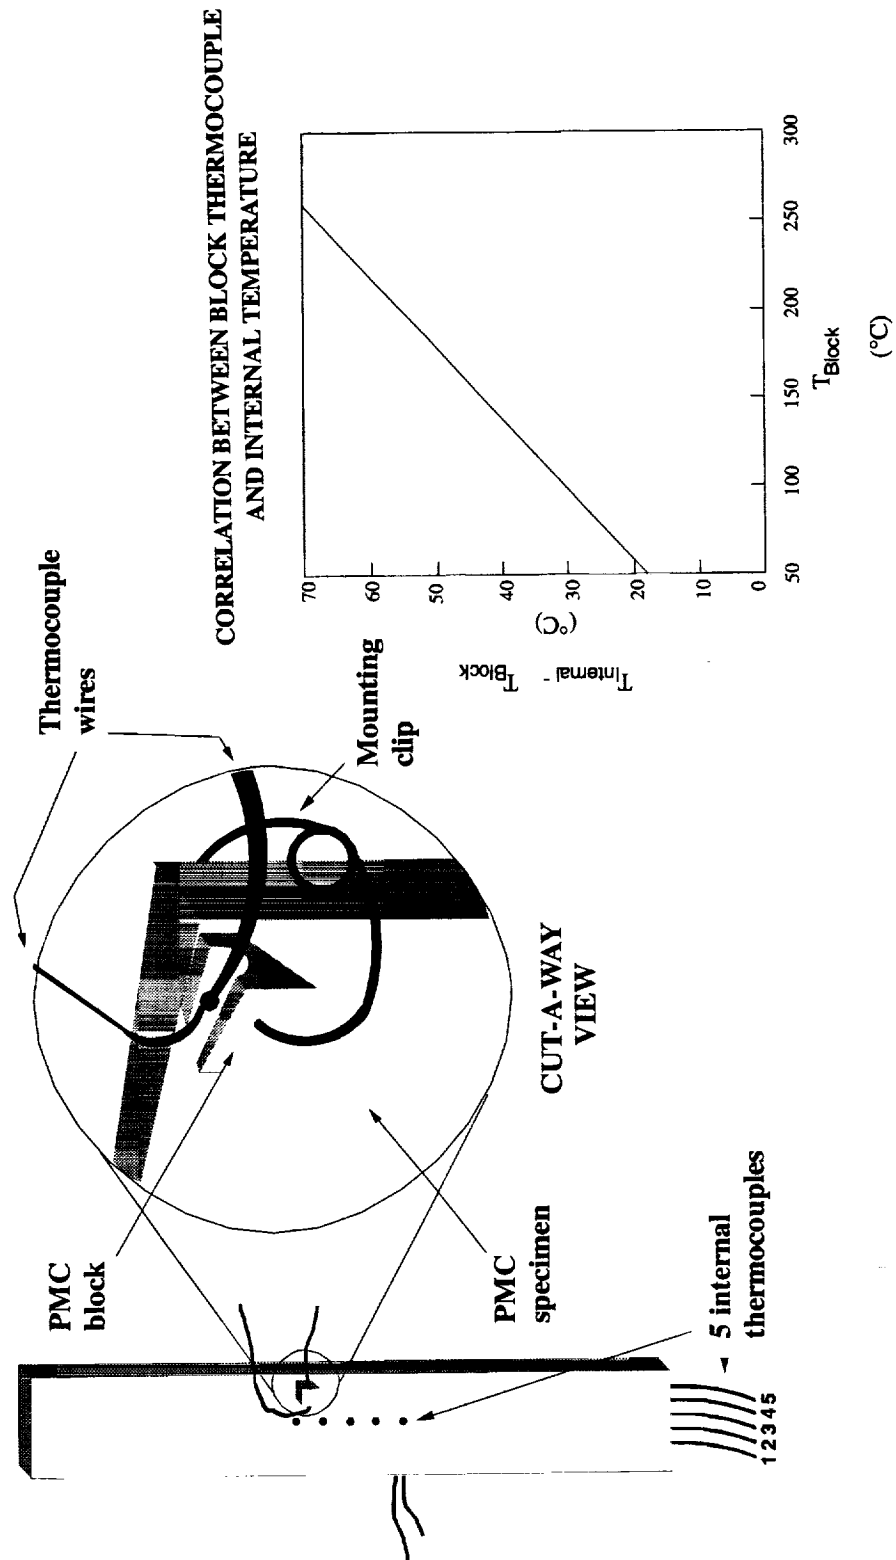
**Figure 2.5** Schematic of calibration specimen, thermocouple block, and typical correlation curve.

A K-type thermocouple was embedded in a block of PMR15 polyimide which was then attached to the coupon using a small stainless steel clip as shown in Figures 2.5 and 2.6. The block was a fiberless composition of PMR15 since the inclusion of conductive carbon fibers would have interfered with the thermocouple current. The block was shaped as a cube with a common length, width and height of 0.254 cm (0.10 in.). For this study a single block

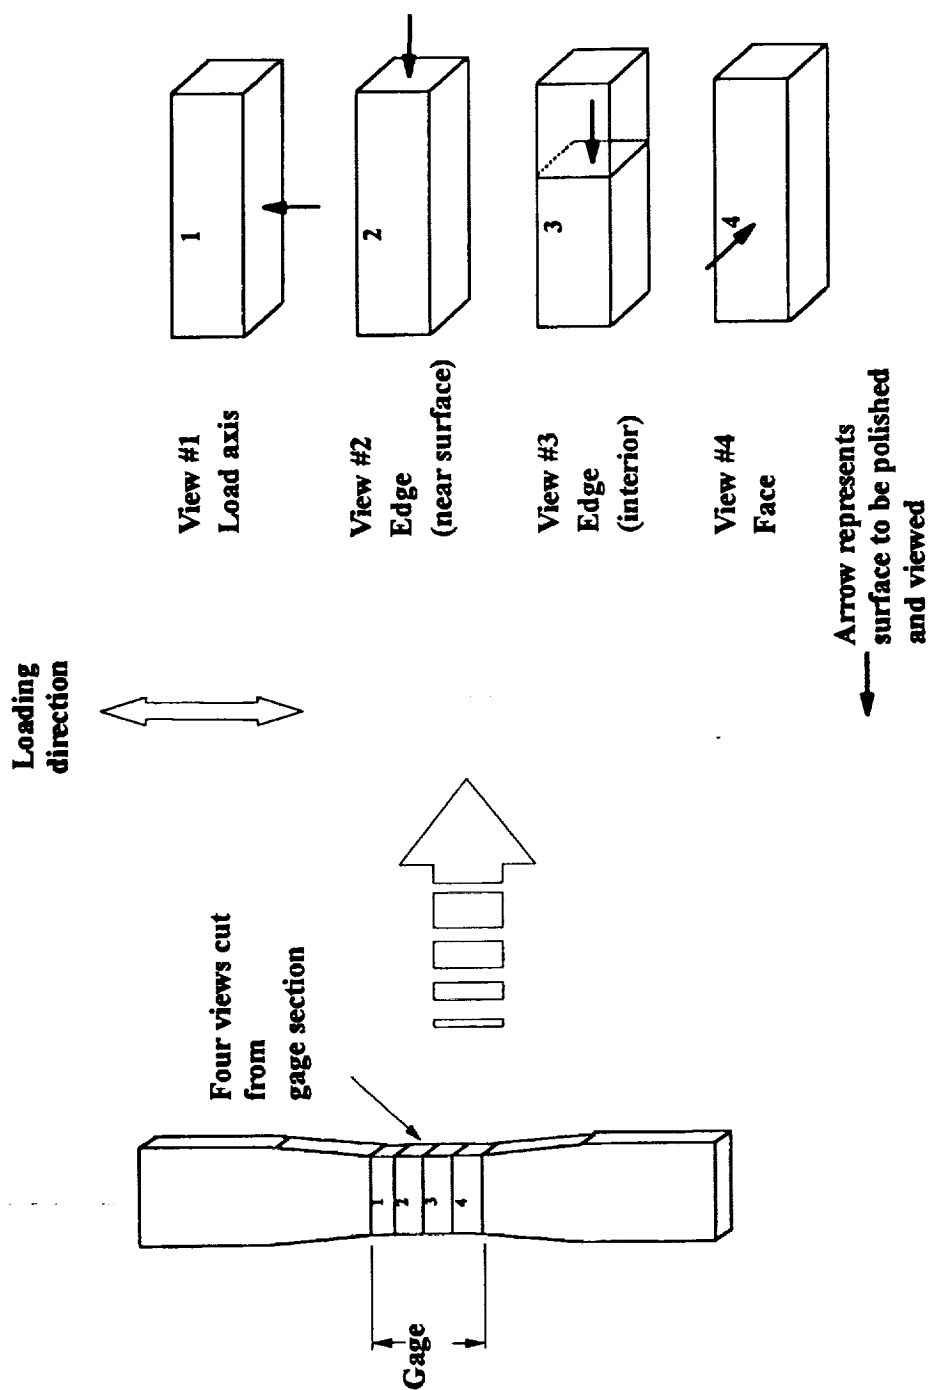
Figure 2.7 Schematic displaying the various views for microstructural analysis.

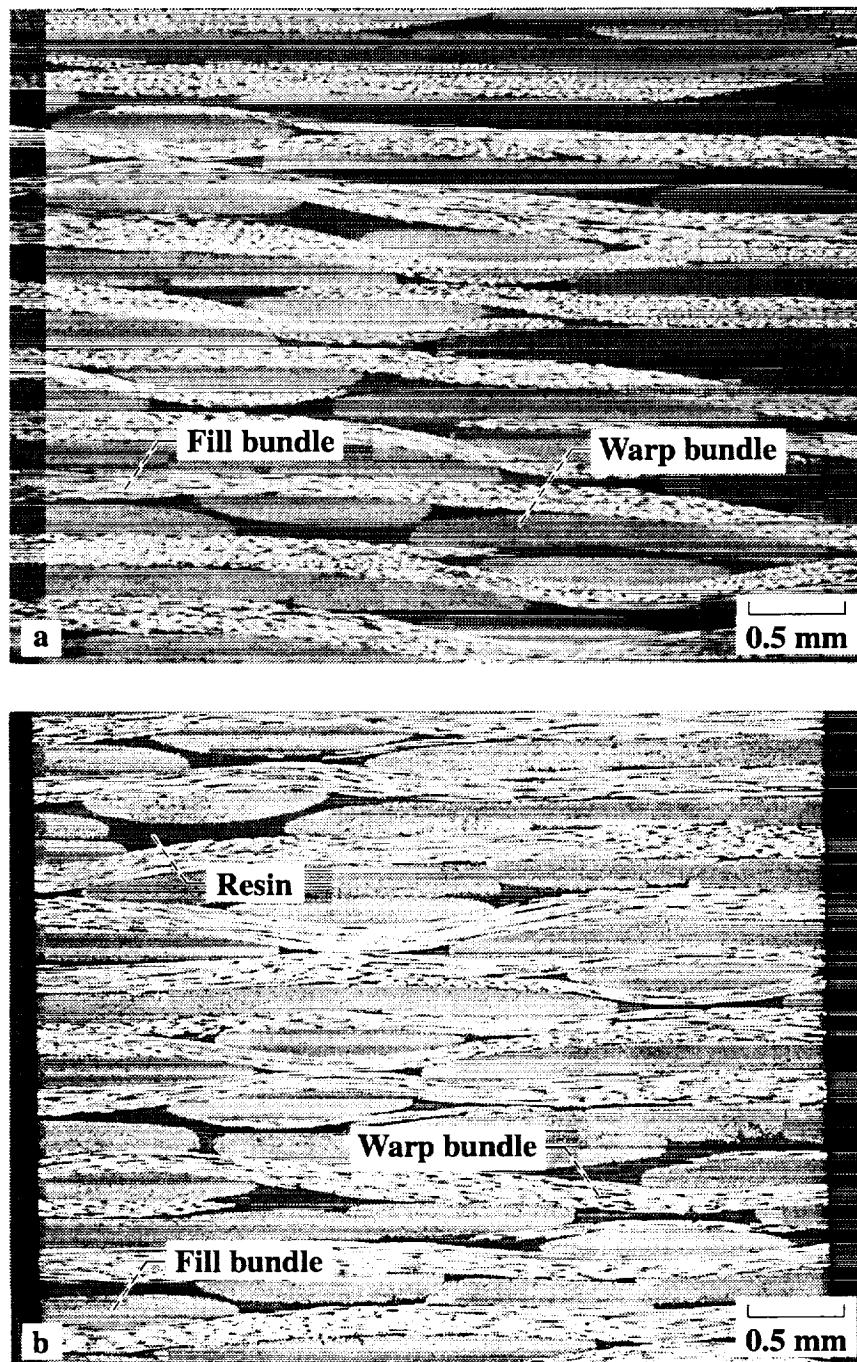
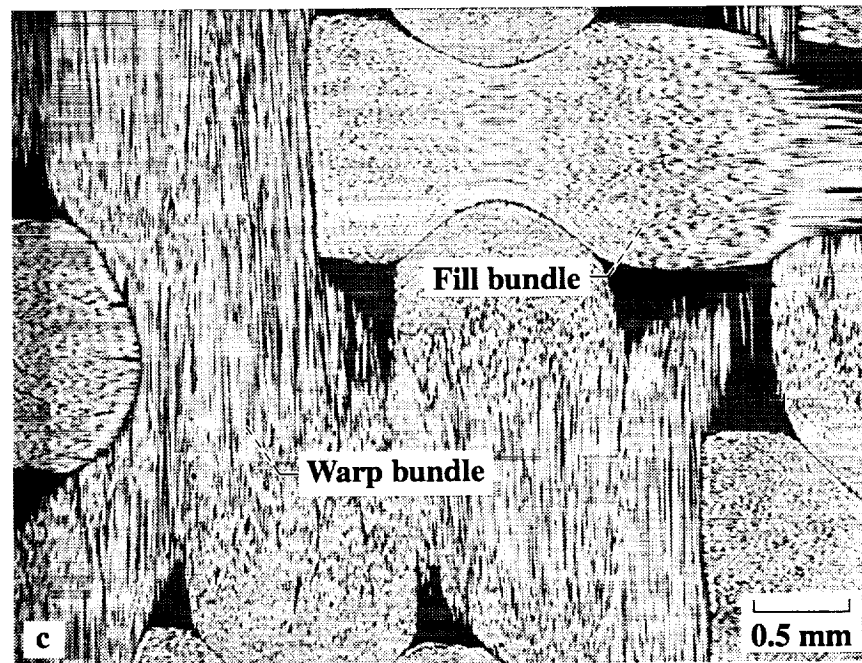
**Figure 2.8** Microscopic views of an undamaged specimen at 25x magnification. (a) View #1, load axis. (b) View #2, edge (equivalent to view #3). (c) View #4, face. See Figure 2.7 for explanation of views.

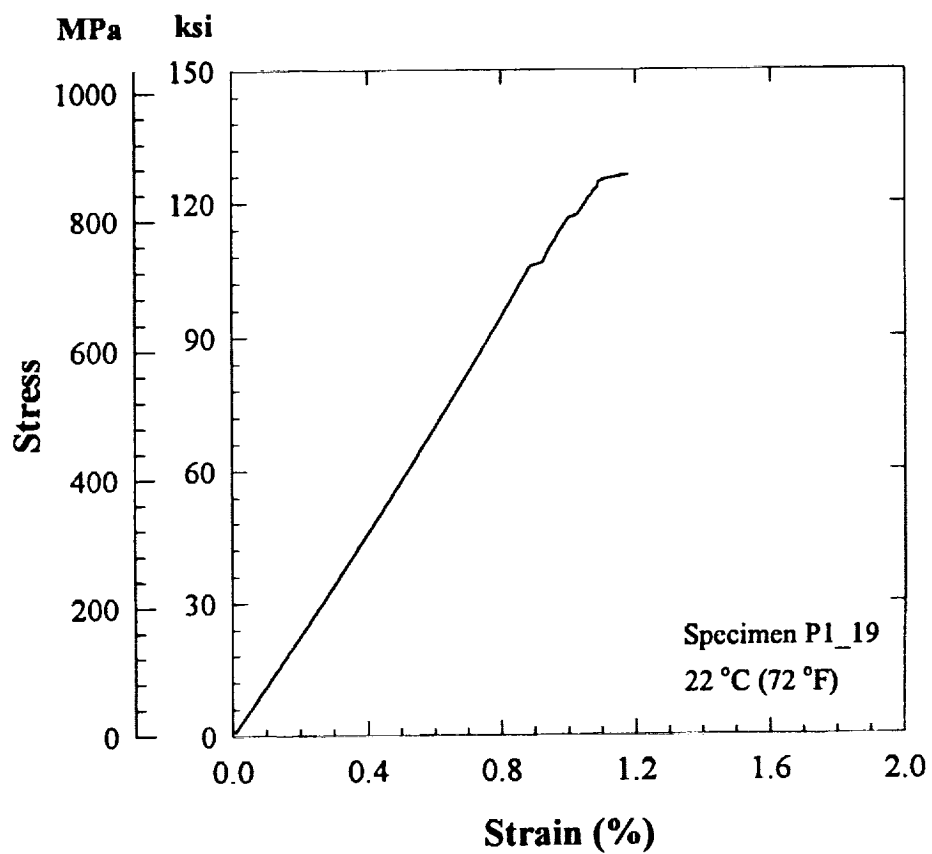
**Figure 3.1** Typical monotonic tensile response of T650-35/PMR15 10-ply, (0/90) weave at 22°C (72°F).

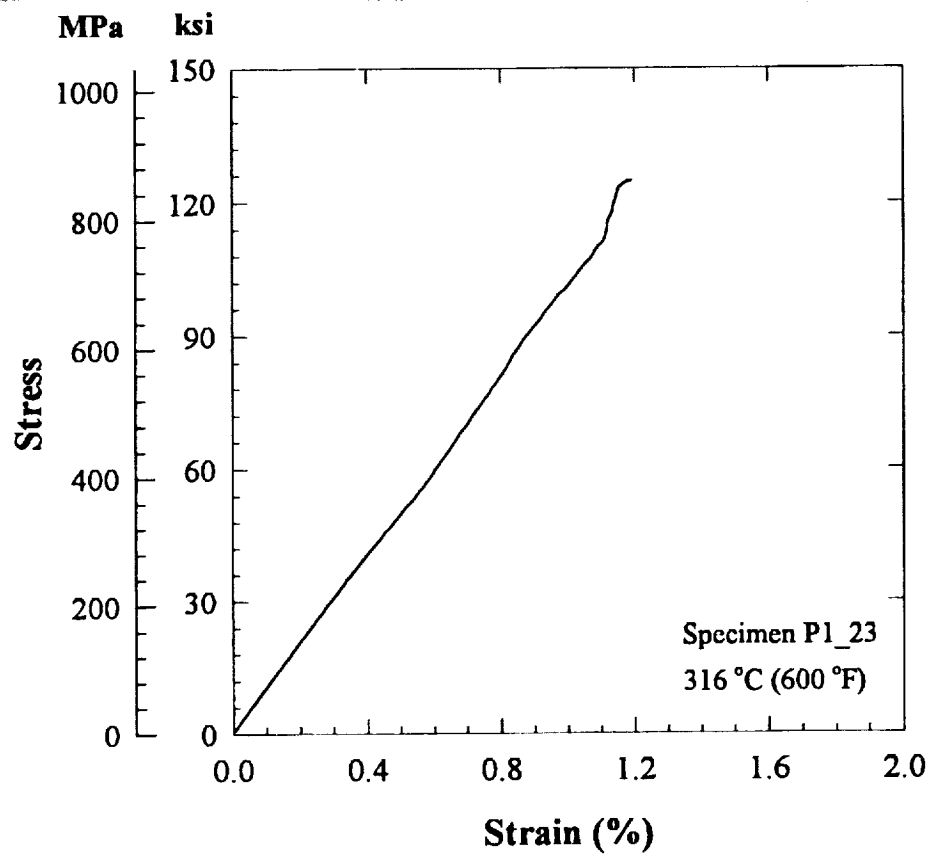
**Figure 3.2** Typical monotonic tensile response of T650-35/PMR15 10-ply, (0/90) weave at 316°C (600°F).

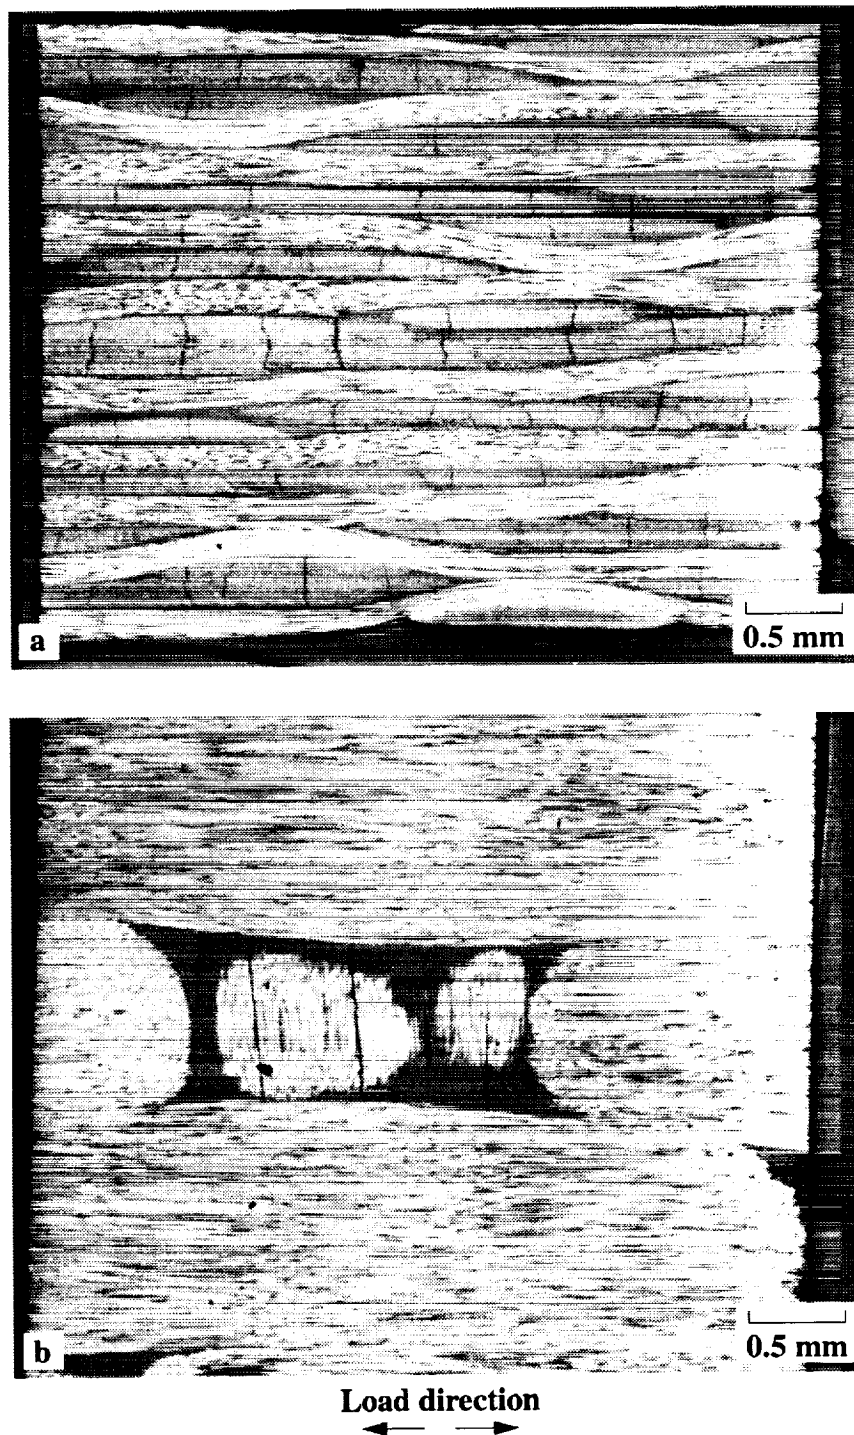
**Figure 3.3** Microscopic view of transverse cracks in 22 °C (72 °F) tensile coupon. (a) Edge (view #2) with 25x magnification. (b) Face view (view #4) with 25x magnification: See Figure 2.7 for explanation of view angle: Specimen P1\_7.

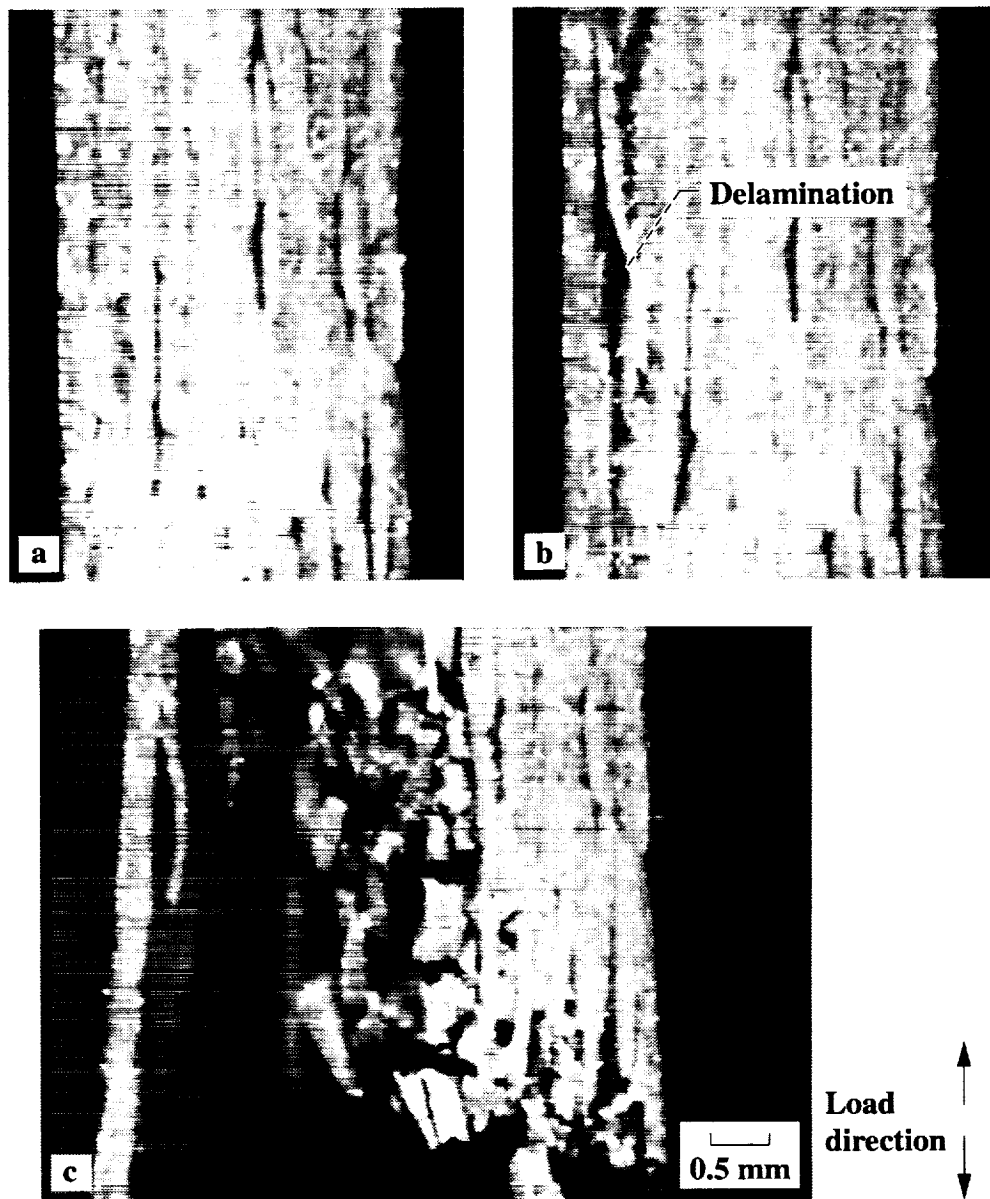
**Figure 3.4** Progressive damage in 22 °C (72 °F) tensile specimen as observed using video images of monitored edge view with 15x magnification. (a) Image taken at 793 MPa (115 ksi) before bundle debond and delamination. (b) Debond and delamination at 827 MPa (120 ksi). (c) Failure at 876 MPa (127 ksi); Specimen P1\_17.

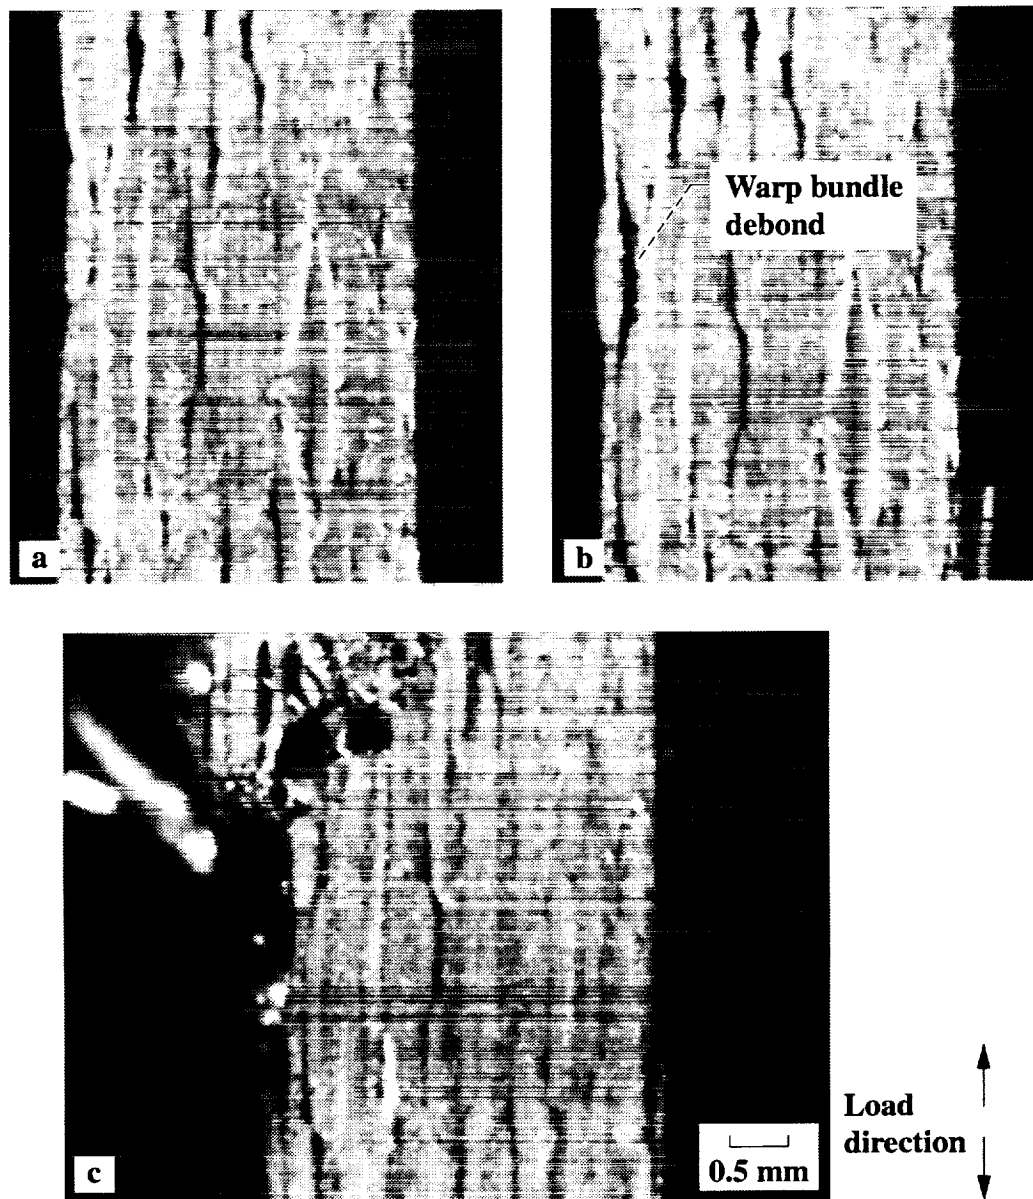
**Figure 3.6** Progressive damage in 316 °C (600 °F) tensile specimen as observed using video images of monitored edge view with 15x magnification. (a) Image taken at 345 MPa (50 ksi) before transverse crack bundle debond. (b) Bundle debond at 414 MPa (60 ksi). (c) Failure at 848 MPa (123 ksi) initiated at bundle debond: Specimen P1\_21.

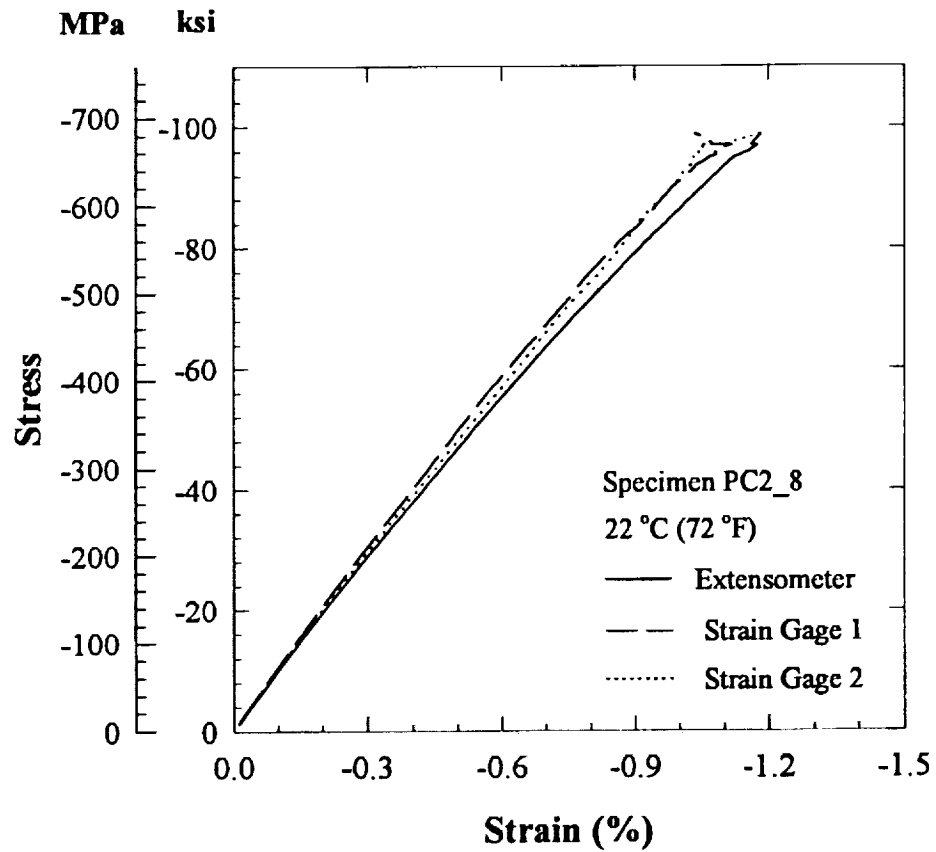
**Figure 3.7** Typical monotonic compressive response of T650-35/PMR15 16-ply (0/90) weave at 22°C (72°F).

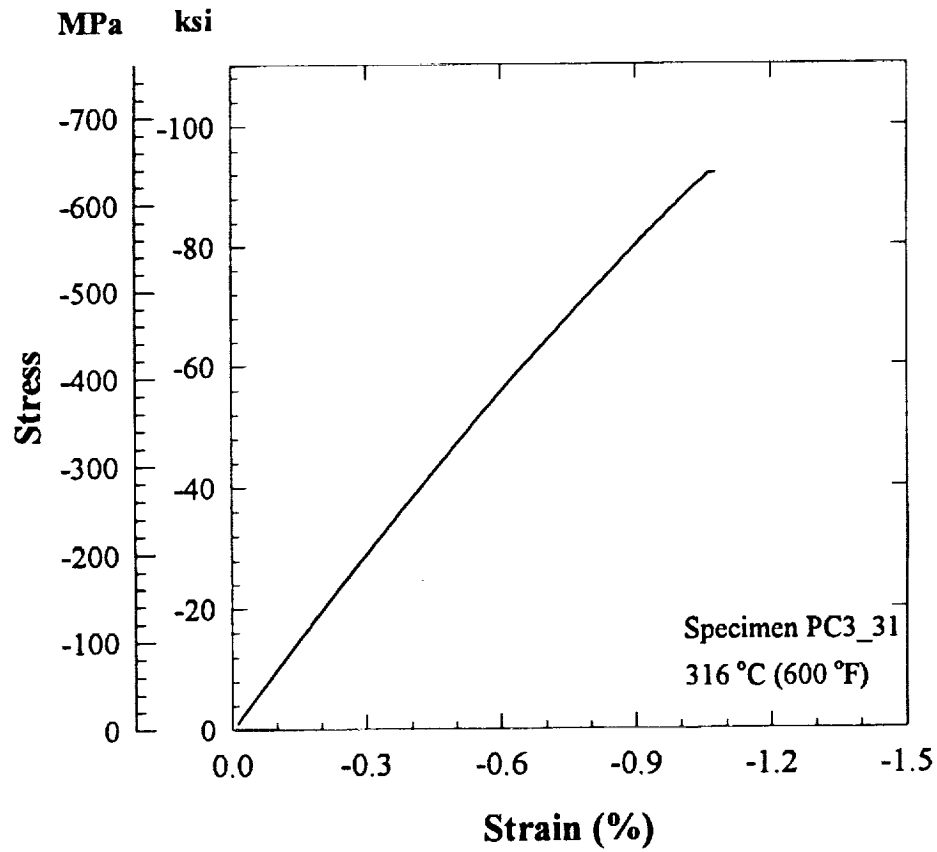
**Figure 3.8** Typical monotonic compressive response of T650-35/PMR15 16-ply (0/90) weave at 316°C (600°F).

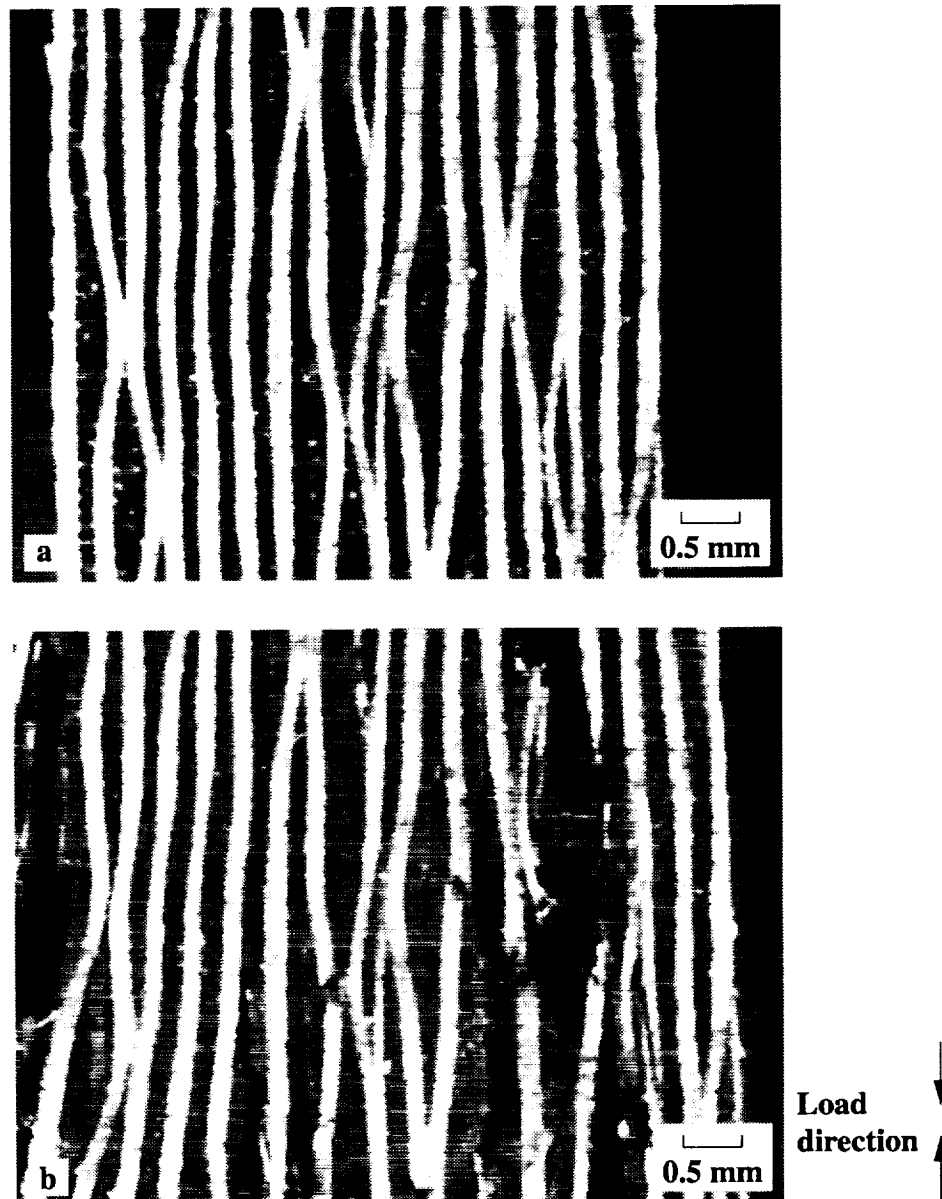
**Figure 3.9** Monotonic compressive coupon at 316 °C (600 °F) as observed using video images of monitored edge view with 15x magnification. (a) Image taken at -593 MPa (-86 ksi); the instant before failure. (b) Failure at -599 MPa (-87 ksi): Specimen PC3\_26.

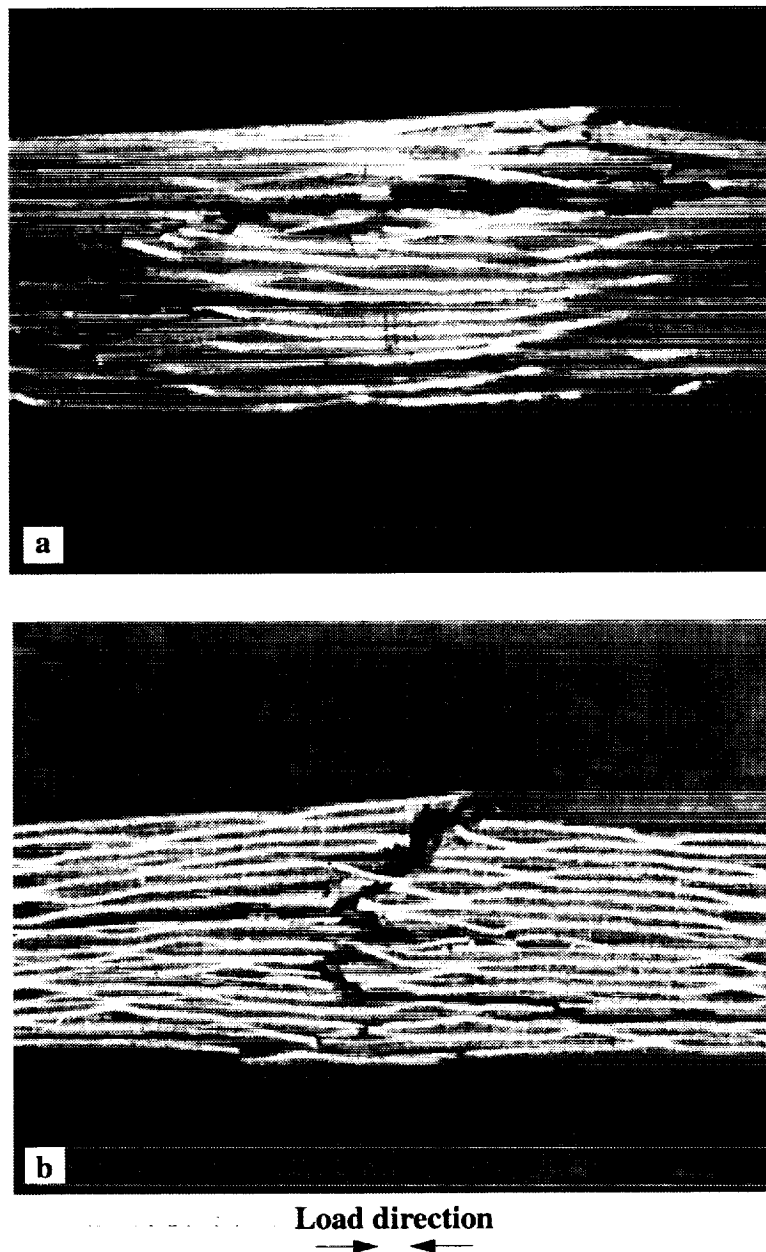
**Figure 3.10** Typical post-failure edge views of compressive specimens at 7.5x magnification. (a) 22 °C (72 °F): Specimen PC1\_3. (b) 316 °C (600 °F): Specimen PC3\_15.

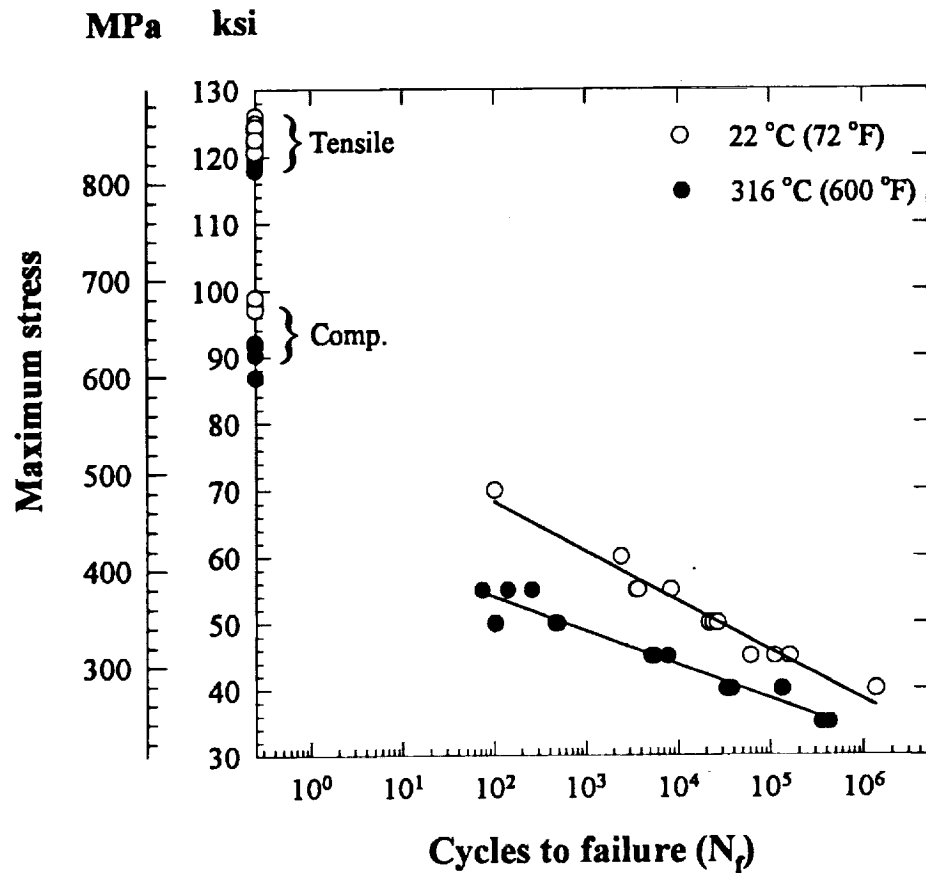
**Figure 3.11** Stress based isothermal fatigue life comparison for T650-35/PMR15 (0/90) weaves at 22 and 316 °C (72 and 600 °F). Test conditions were  $R_\sigma = -1$  and  $Freq. = 2$  Hz.
